Manhole Inspection Summary

Manhole # S13EE_034MH

Insp Date: **2/5/09 9:10 AM**

Location Address: **1318 BLOOMINGDALE RD** Cross Street: **BELMONT AVE**

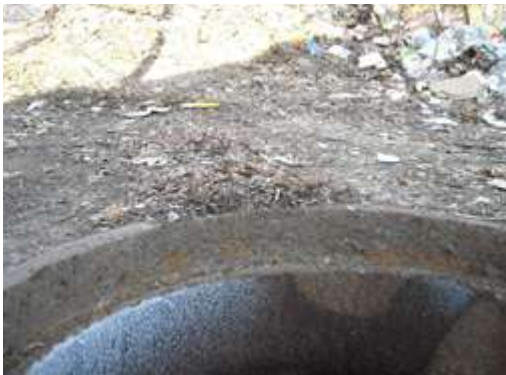
EVIDENCE OF INFLOW DUE TO SHEETING - NOTE LEAVES PILED ON FRAME FROM ALLEY DRAINAGE

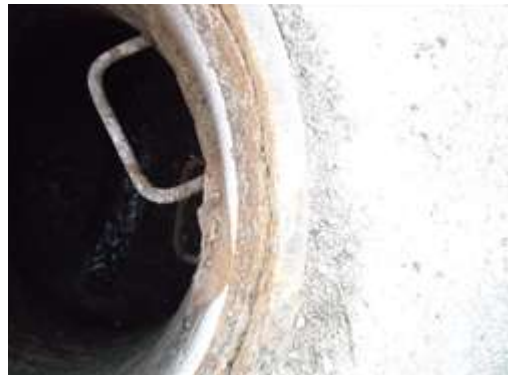
Defect 6

Frame Offset: **1** (in.) Condition: ☒ Sound ☐ Cracked ☐ Leaks

FRAME OFFSET 1"

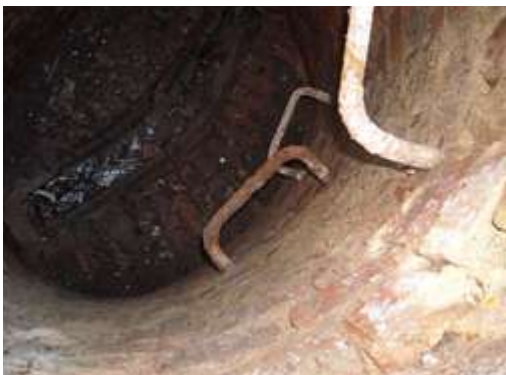
Defect 5

Steps Count: **3** Missing: **0** ☒ **Corroded**

CORRODED STEPS

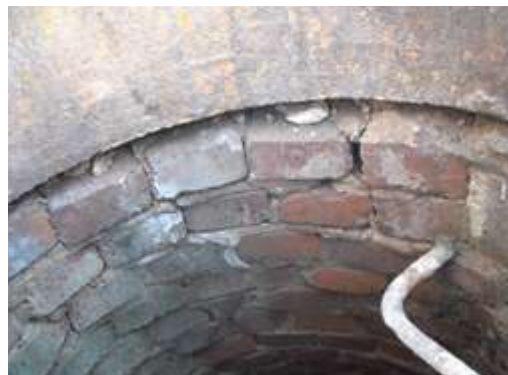
Defect 4

Corbel Material: **Brick** ☐ Parged Type: **Concentric/Eccentric**
Condition: ☐ Sound ☒ **Cracked** ☐ Root Intrusion ☒ **Loose Brick** ☒ **Deteriorated**
Infiltration: ☒ None ☐ Joint ☐ Cracks ☐ Mortar ☐ Roots ☐ Wall

BRICKS MISSING BELOW FRAME, CRACKED BRICKS AND MISSING MORTAR, DETERIORATION

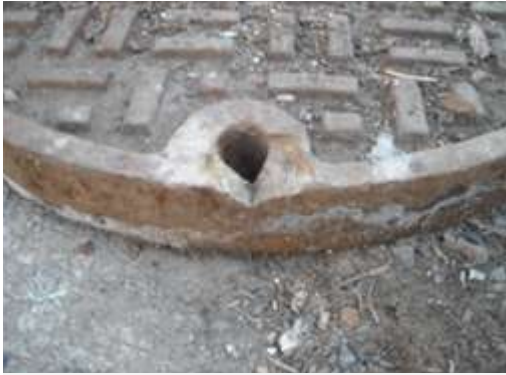
Defect 3

Cover Shape: **Circular** Diameter: **24** (in.) Length: (in.) Dist A/B Grade: **0** (in.)
Type: **Sanitary** Condition: **Cracked** Cover Material: **Cast Iron**
Properties: ☐ Bolted ☐ Vented ☐ Water Tight ☐ Water Tight Insert

CRACKED MANHOLE LID

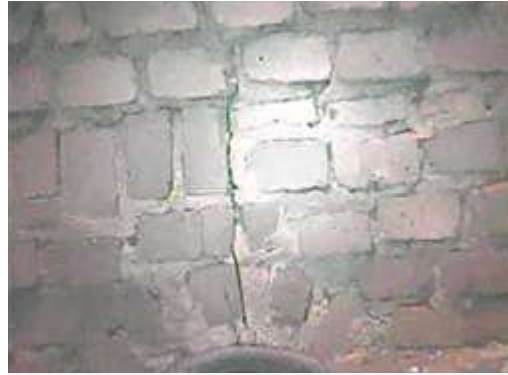
Defect 2

Barrel Material: **Brick** ☐ Parged
Shape: **Circular** Diameter: **42** (in.) Length: (in.)
Condition: ☐ Sound ☒ **Cracked** ☐ Root Intrusion ☐ Loose Brick ☐ Deteriorated
Infiltration: ☒ None ☐ Joint ☐ Cracks ☐ Mortar ☐ Roots ☐ Wall

CRACKED BARREL WALL ABOVE 12 OCLOCK

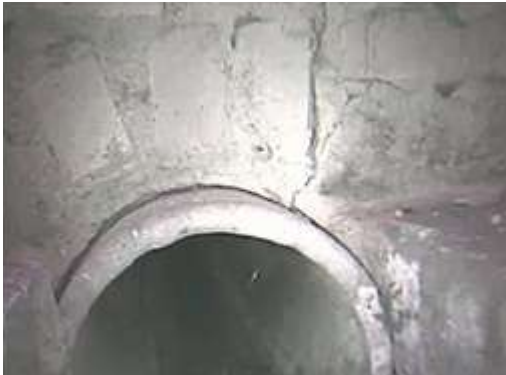
Defect 1

CRACK IN BARREL WALL ABOVE CONNECTION

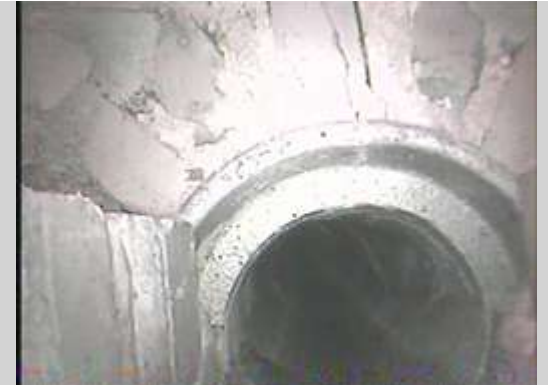
12 O'Clock Outflow

Pipe Height: **9.6** (in.) Rod and Bar (Angled)
Pipe Material: **Clay** ☐ Pipe Lined
Invert Depth: **7.10** (ft.) Flow Characteristics: **Slow**
Deposits: ☒ None ☐ Mud ☐ Sludge ☐ Debris ☐ Grease
Silt Depth: (in.) Deposits Extent:
Infiltration: **None** Pipe Seal Cond: **Cracked**
